Property Condition Assessment

North Edmonton Industrial Park

12345 Industrial Park Drive, Edmonton, Alberta • 2025-08-29

Reference: BRK-SAMPLE-002

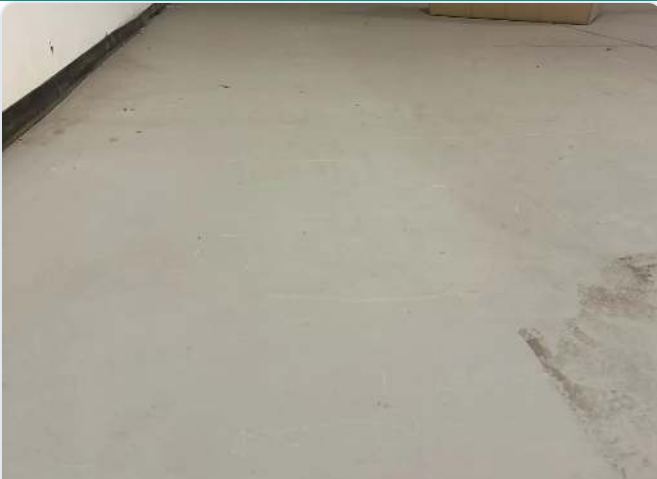
A1030 Slab on Grade (Concrete Floor - Warehouse)

CONDITION: ● B (Good)

DEFICIENCY: The warehouse concrete slab shows extensive scratches, scuff marks, and significant water pooling with staining, indicating active water intrusion.

RECOMMENDATION: Investigate the source of water intrusion to prevent further damage and repaint the concrete slab to restore its protective coating.

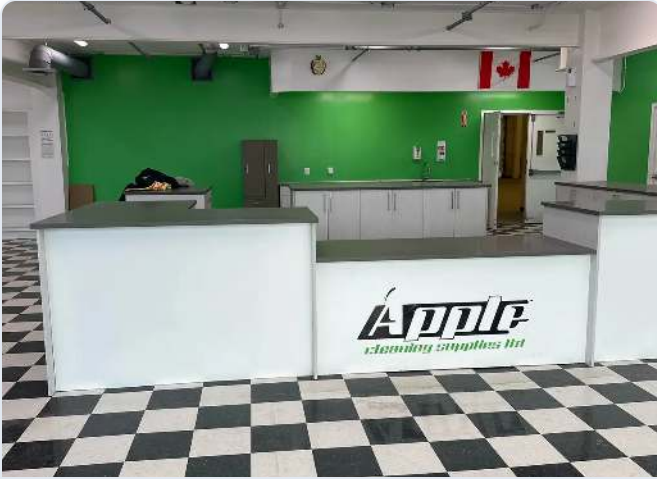
C1030 Base Cabinets - Laminate

- CONDITION:** ● B (Good)
- LOCATION:** Main Entrance Area
- COMPONENT:** C1030 Fittings
- DEFICIENCY:** Laminate base cabinets and gray countertops in the main entrance area appear clean and undamaged.
- RECOMMENDATION:** Continue with routine cleaning and maintenance to preserve the good condition of the cabinets and countertops.

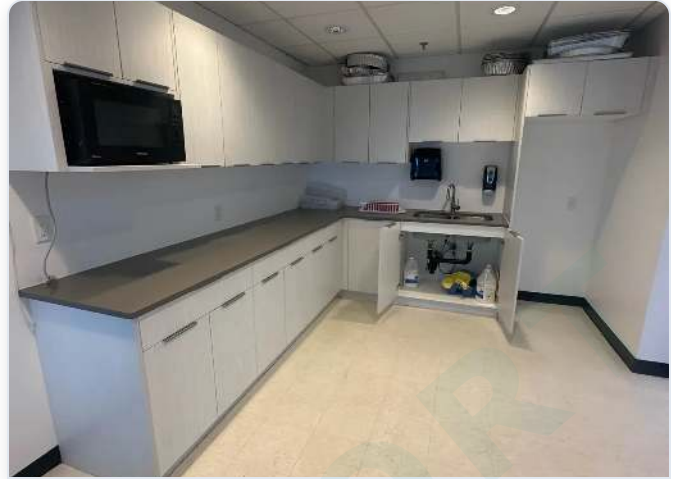
C1030 Kitchenette Millwork

- CONDITION:** ● C (Acceptable)
- LOCATION:** Kitchenette
- COMPONENT:** C1030 Fittings
- DEFICIENCY:** Kitchenette millwork exhibits minor scuffs and scratches on cabinet surfaces and countertops, consistent with its age and use.
- RECOMMENDATION:** Monitor the kitchenette millwork for further deterioration and plan for future refurbishment or replacement as wear progresses.

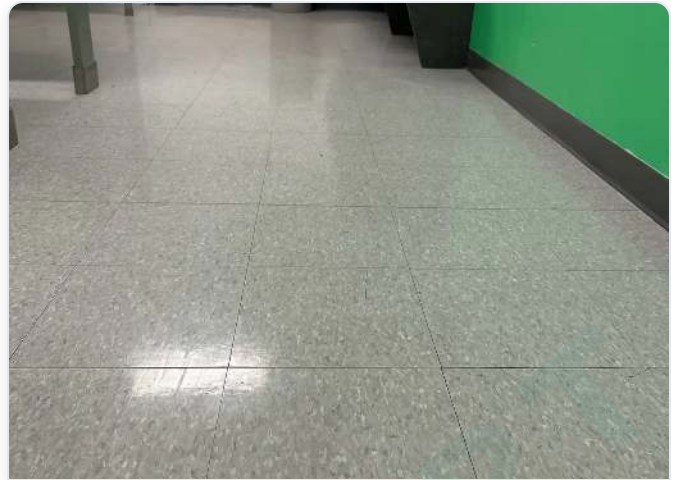
C3020 Vinyl Composition Tile

CONDITION: ● C (Acceptable)
LOCATION: General
COMPONENT: C3020 Floor Finishes
DEFICIENCY: The light gray VCT flooring throughout the warehouse exhibits scuff marks and minor discoloration, indicating moderate wear.
RECOMMENDATION: Implement a routine floor care program to address scuffing and discoloration of the VCT flooring.

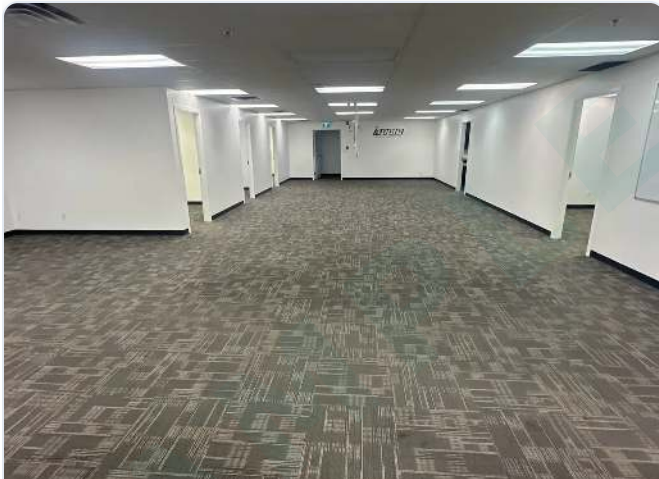
C3020 Carpet Tiles - Office Area

CONDITION: ● B (Good)
LOCATION: General Office Area
COMPONENT: C3020 Floor Finishes
DEFICIENCY: Carpet tiles in the office area are in good condition, showing no visible wear, tears, or significant staining.
RECOMMENDATION: Continue routine cleaning and maintenance to preserve the carpet tiles' current good condition.

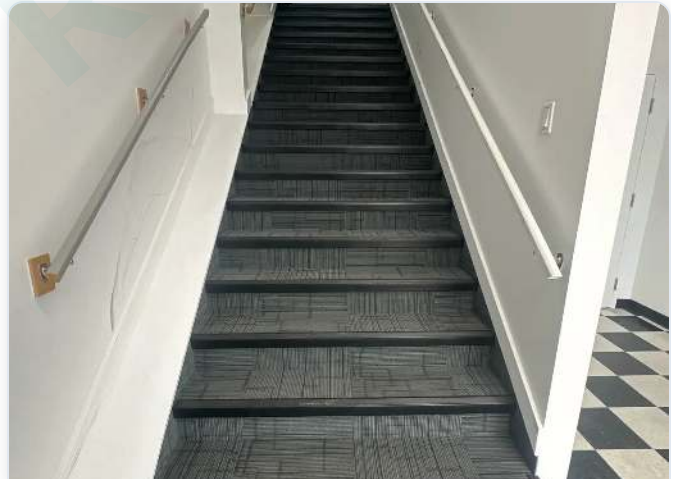
C2020.06.01 Carpet Stair Treads and Risers

CONDITION: ● C (Acceptable)
LOCATION: General
COMPONENT: C3020 Floor Finishes
DEFICIENCY: Stair finishes are high-wear surfaces and are subject to accelerated deterioration from foot traffic.
RECOMMENDATION: Monitor the condition of the carpet stair finish and nosing components.

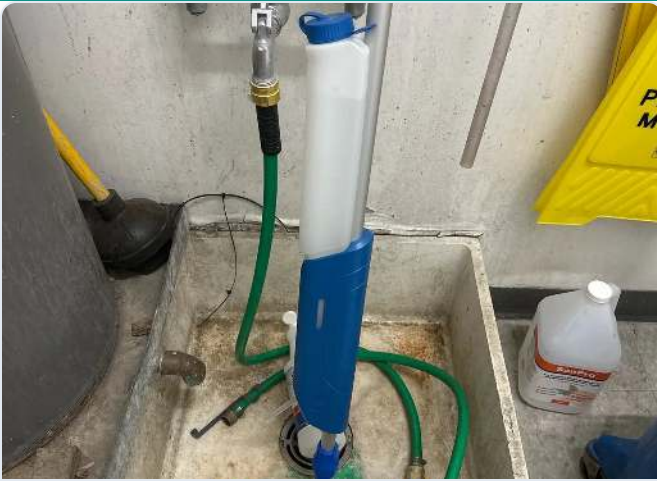
D2010 Utility Sink

CONDITION: ● B (Good)
LOCATION: Janitor Room (Warehouse)
COMPONENT: D2010 Plumbing Fixtures
DEFICIENCY: The utility sink in the janitor room exhibits minor staining and wear consistent with regular use.
RECOMMENDATION: Continue routine cleaning and maintenance of the utility sink and its associated fixtures.

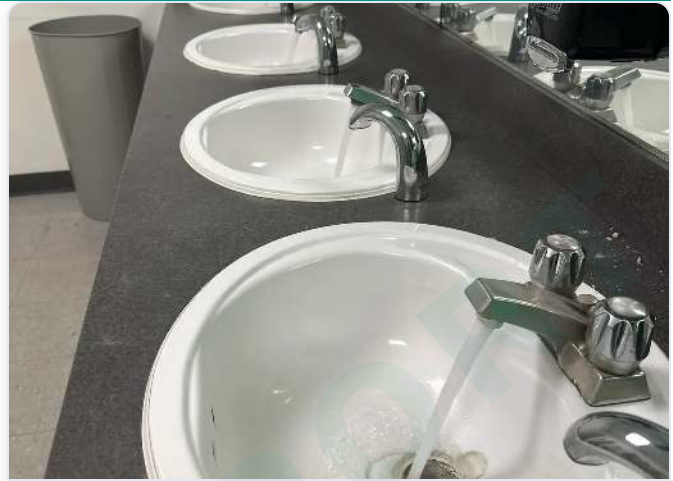
D2010.04 Lavatories / Faucets

CONDITION: ● D (Marginal)
LOCATION: Restroom
COMPONENT: D2010 Plumbing Fixtures
DEFICIENCY: None
RECOMMENDATION: Continue maintenance

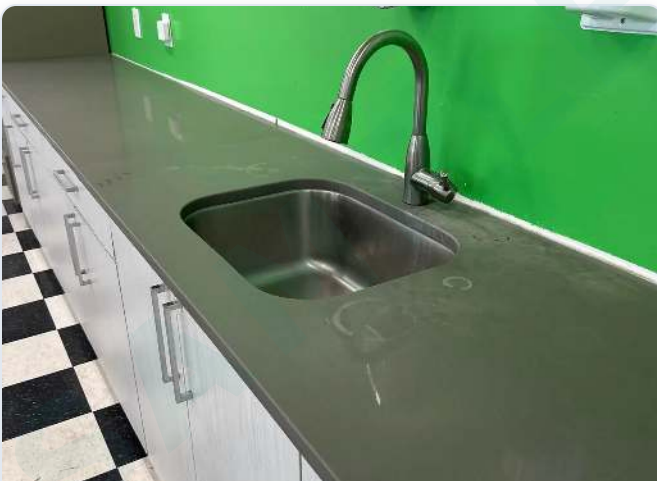
D2010 Plumbing Fixtures - Kitchen

CONDITION: The kitchen sink faucet at the main lobby kitchenette was observed to be non-functional, indicating a critical failure of the domestic water system to this fixture or the faucet mechanism itself. The P-trap assembly shows signs of minor corrosion and wear, indicating potential for future leaks if not regularly inspected and maintained.

CONDITION: ● D (Marginal)
LOCATION: Front Lobby Area
COMPONENT: D2010 Plumbing Fixtures
DEFICIENCY: The gooseneck faucet at the reception area kitchen sink is non-functional, indicating a failure in the water supply or faucet mechanism.
RECOMMENDATION: Immediately repair or replace the non-functional gooseneck faucet at the reception area kitchen sink to restore operability.

ACTION: Repair or replace the non-functional faucet. Check with seller to confirm that water supply was not turned off. Inspect and repair or replace the P-trap assembly as needed.

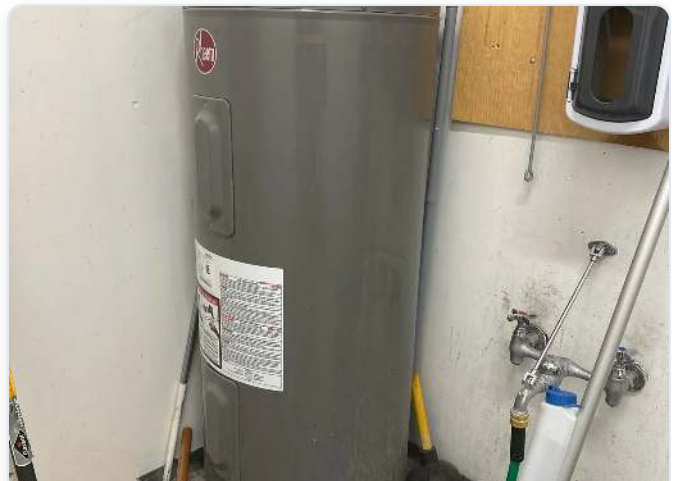
D2020 Electric Water Heater

CONDITION: Minor corrosion is present on some copper pipe fittings, which could lead to leaks if not addressed. The water heater is 12 years old and surpassed useful life. However, it appears to be in good condition with no visible leaks.

CONDITION: ● C (Acceptable)
LOCATION: General
COMPONENT: D2020 Domestic Water Distribution
DEFICIENCY: Minor corrosion is visible on copper pipe fittings connected to the water heater, indicating potential future leaks.
RECOMMENDATION: Monitor the corroded copper pipe fittings regularly for worsening conditions and plan for future replacement.

ACTION: Lifecycle Replacement Allowance Provided. Allowance includes supply and installation of a like-for-like electric tank, typical connections, and removal/disposal of the existing unit. Excludes electrical panel/circuit upgrades, significant piping rework, and code-driven changes beyond like-for-like.
