Property Condition Assessment

Westbrook Community Arena

123 Arena Boulevard, Edmonton, Alberta • 2023-09-15

Reference: BRK-SAMPLE-001

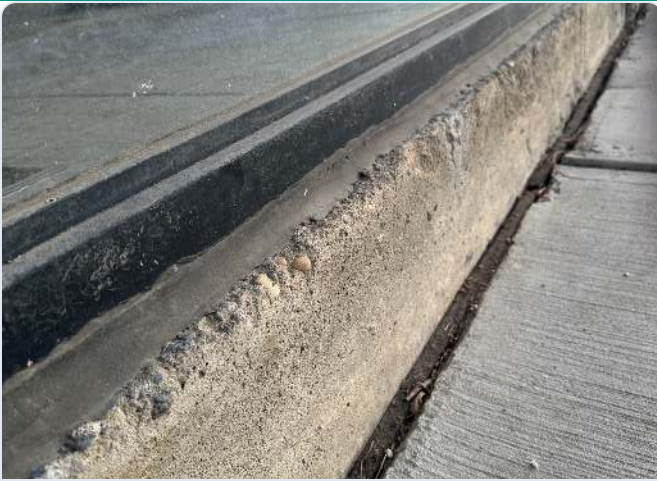
A1020.07 Grade Beams (Concrete)

Short-Term	3 items	\$18,690
<p>A1020.07 Grade Beams (Concrete) \$12,790</p> <p>CONDITION: Spalling and deterioration of the concrete grade beam, which can lead to further structural degradation and potential water intrusion if not addressed. The exposed aggregate indicates loss of the cementitious paste.</p> <p>ACTION: Repair spalled concrete sections of the grade beam. This may involve chipping away loose material, cleaning the surface, applying a bonding agent, and patching with a suitable concrete repair mortar. Monitor for further deterioration.</p>		
<p>B2010.01.11 Exterior Sealants (Window Perimeter) \$4,000</p> <p>CONDITION: Deteriorated and failing sealant joint, which compromises the weather seal and allows for water and air infiltration into the building envelope. This can lead to moisture damage and energy loss.</p> <p>ACTION: Remove existing deteriorated sealant, clean the joint thoroughly, install backer rod if necessary, and apply new high-performance exterior sealant to ensure a watertight and airtight seal.</p>

CONDITION: ● C (Acceptable)

LOCATION: Exterior, at base of window system

DEFICIENCY: Spalling and deterioration of the concrete grade beam, which can lead to further structural degradation and potential water intrusion if not addressed. The exposed aggregate indicates loss of the cementitious paste.

RECOMMENDATION: Repair spalled concrete sections of the grade beam. This may involve chipping away loose material, cleaning the surface, applying a bonding agent, and patching with a suitable concrete repair mortar. Monitor for further deterioration.

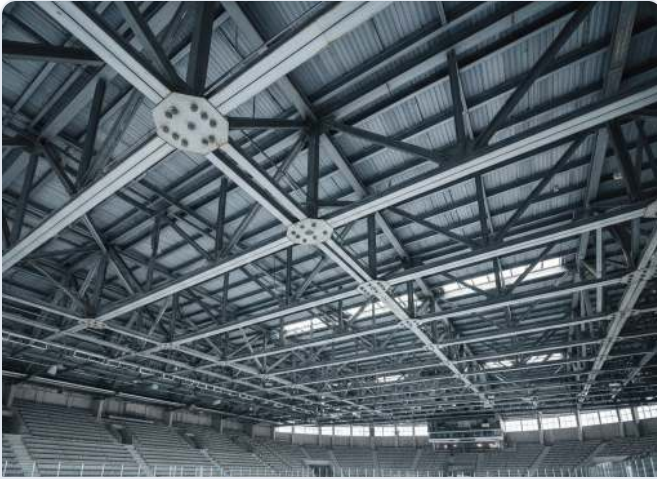
B1020.01.03.02 Roof Steel Trusses*

CONDITION: ● A (Excellent)
LOCATION: Arena Roof Structure
COMPONENT: Roof Structural Frame
DEFICIENCY: None noted
RECOMMENDATION: Routine maintenance.

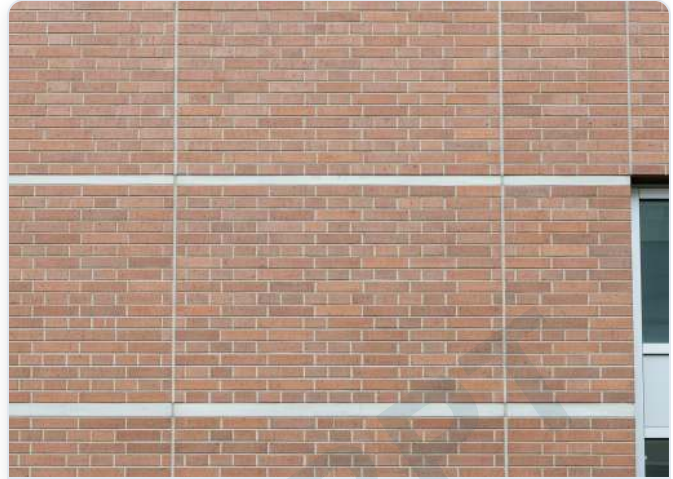
B2010.01.02.01 Masonry Cladding*

The exterior wall system of the Westbrook Community Arena is primarily comprised of two distinct cladding materials: masonry and phenolic panel siding. The masonry cladding, installed in 2010 with an expected design life of 75 years, is generally observed to be in good condition. However, a specific deficiency was noted where five individual masonry panels exhibit cracking or are entirely missing. This localized damage compromises the aesthetic integrity and could potentially lead to moisture infiltration if not addressed. The phenolic panel siding, also installed in 2010 with an anticipated design life of 50 years, is in excellent condition with no notable concerns or deficiencies observed during the assessment.

CONDITION: ● B (Good)
LOCATION: Exterior - Multiple Elevations
COMPONENT: Exterior Wall Exterior Skin
DEFICIENCY: Five panels are cracked or missing.
RECOMMENDATION: Replace damaged cladding panels.

The identified damage to the masonry cladding constitutes a short-term priority. The replacement of the five cracked or missing panels is recommended to prevent further deterioration, maintain the building's envelope integrity, and restore its appearance. This repair is considered a deferred maintenance item requiring prompt attention. Conversely, the phenolic panel siding is performing as expected and does not require any immediate intervention. Its end-of-life replacement should be factored into long-term capital reserve planning, aligning with its projected design life.

<p>B2010.01.02.01 Masonry Cladding* \$1,900</p> <p>CONDITION: Five panels are cracked or missing.</p> <p>ACTION: Replace damaged cladding panels.</p>

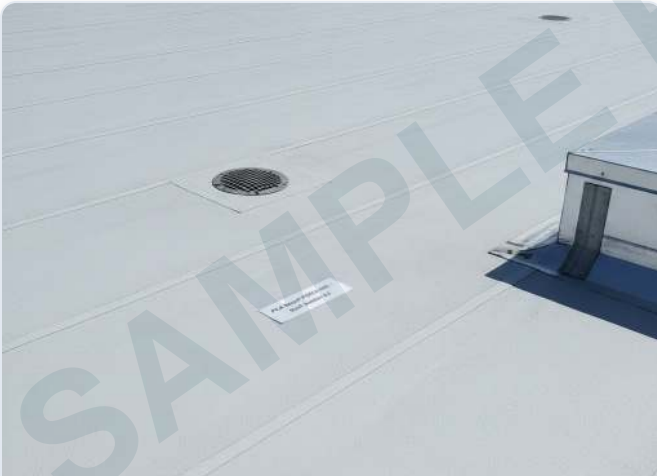
B3010.04.05 Single-Ply Membrane Roof**

CONDITION: ● B (Good)
LOCATION: Roof Level
COMPONENT: B3010.04.05 Membrane Roofing (Single Ply EPDM)
DEFICIENCY: Localized areas of loose membrane observed; minor patched punctures from mechanical damage. No active leaks reported. Manufacturer warranty covers leak repairs in early years.
RECOMMENDATION: Full membrane replacement. Noted deficiencies may shorten service life.

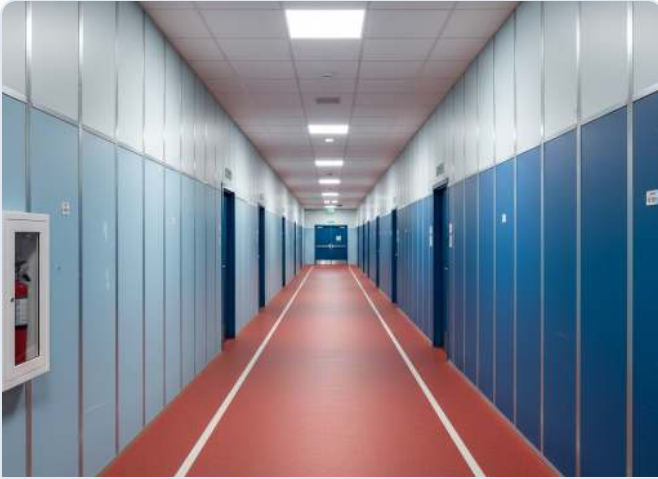
C1010.01.07 Metal Stud Partitions*

CONDITION: ● A (Excellent)
LOCATION: Multi-Purpose Room
COMPONENT: C1010.08 Other Partitions - 2010
DEFICIENCY: Minor surface damage in the multi-purpose room.
RECOMMENDATION: Patch and repaint as routine maintenance.

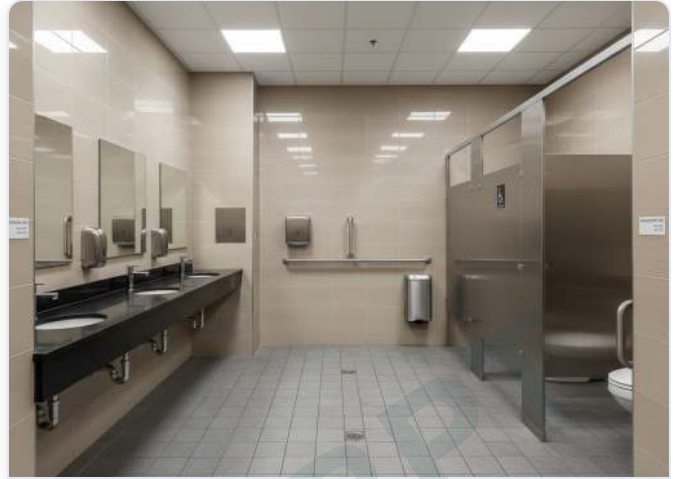
C3010.06.01 Wall Ceramic Tile**

CONDITION: ● A (Excellent)
LOCATION: Change Rooms
COMPONENT: C3010.02 Wall Paneling - 2010
DEFICIENCY: None noted
RECOMMENDATION: Lifecycle replacement

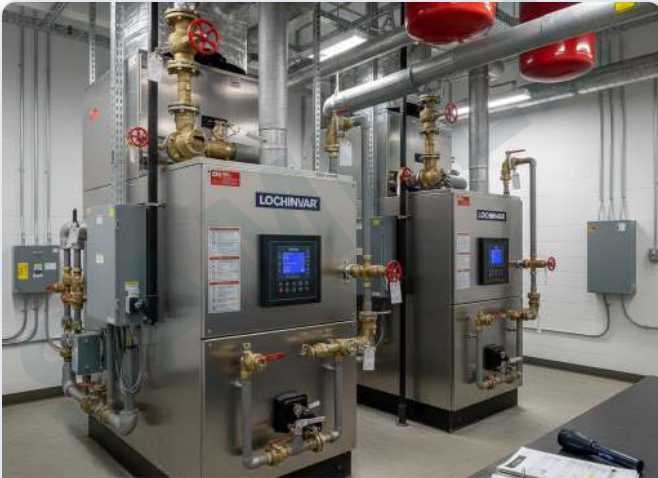
D3020.02.01 Heating Plant**

CONDITION: ● N/A
LOCATION: Main Mechanical Room
COMPONENT: Heat Generating Systems
DEFICIENCY: None noted
RECOMMENDATION: Lifecycle replacement.

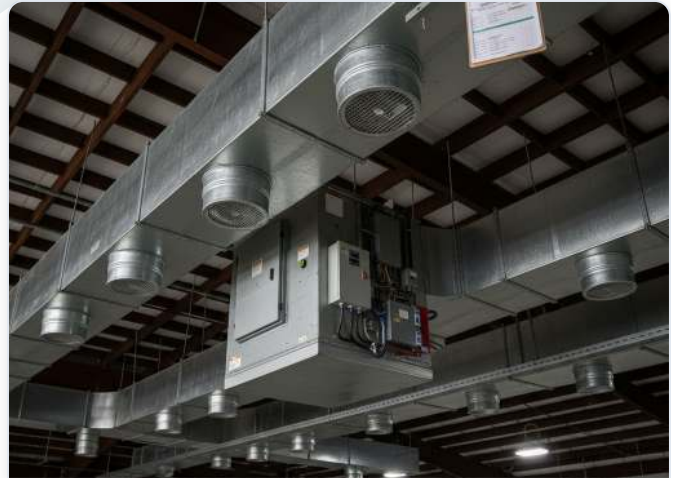
D3040.01.01 Air Handling Unit (Overhaul)**

CONDITION: ● A (Excellent)
LOCATION: Main Mechanical Room
COMPONENT: HVAC Distribution
DEFICIENCY: None noted
RECOMMENDATION: Mid-life overhaul including VFD replacement.

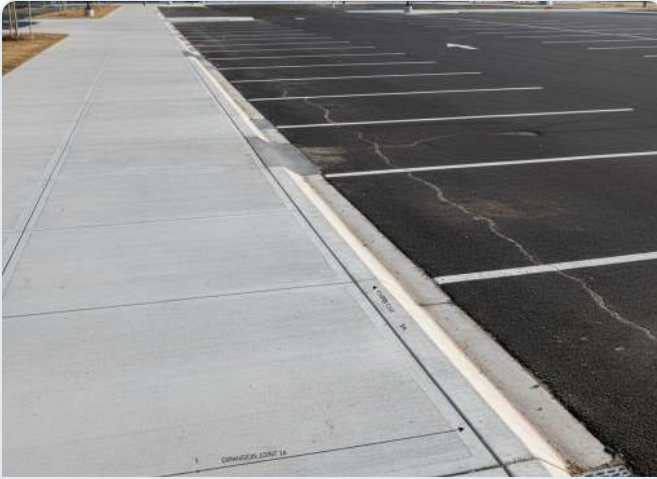
G2030.04 Concrete Sidewalks**

CONDITION: ● A (Excellent)
LOCATION: Exterior - Perimeter
COMPONENT: Pedestrian Paving
DEFICIENCY: None noted
RECOMMENDATION: Lifecycle replacement.

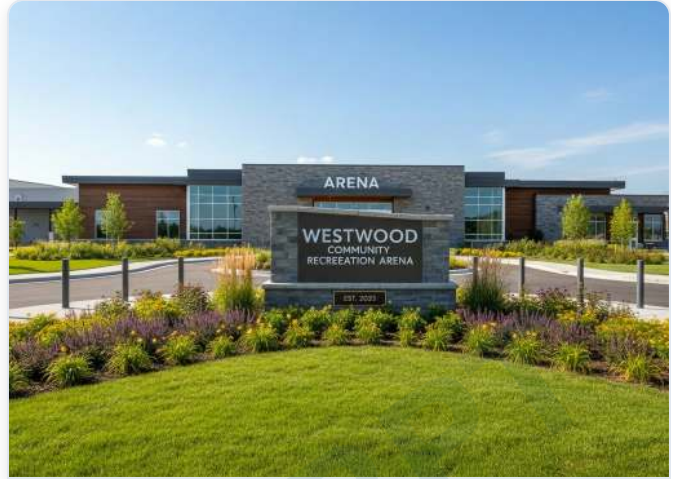
G2050.05 Landscaping*

CONDITION: ● A (Excellent)
LOCATION: Exterior - Grounds
COMPONENT: Landscaping
DEFICIENCY: None noted
RECOMMENDATION: Continue monitoring.

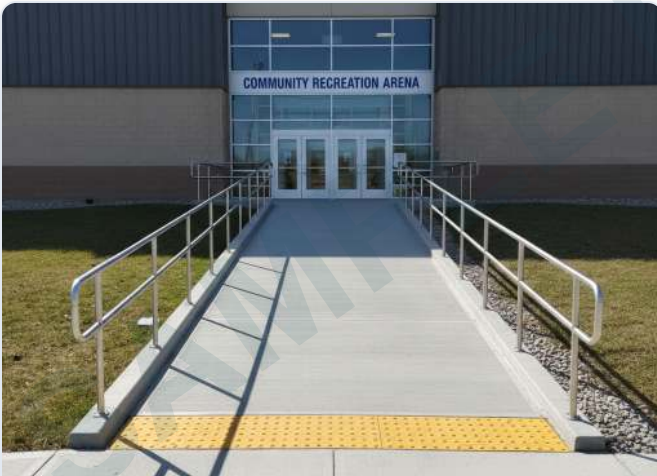
K4010.01 Barrier-Free Route*

CONDITION: ● N/A
LOCATION: General
COMPONENT: Barrier-Free Access
DEFICIENCY: None noted
RECOMMENDATION: Continue monitoring.
