Property Condition Assessment

Westbrook Community Arena

123 Arena Boulevard, Edmonton, Alberta • 2023-09-15

Reference: BRK-SAMPLE-001

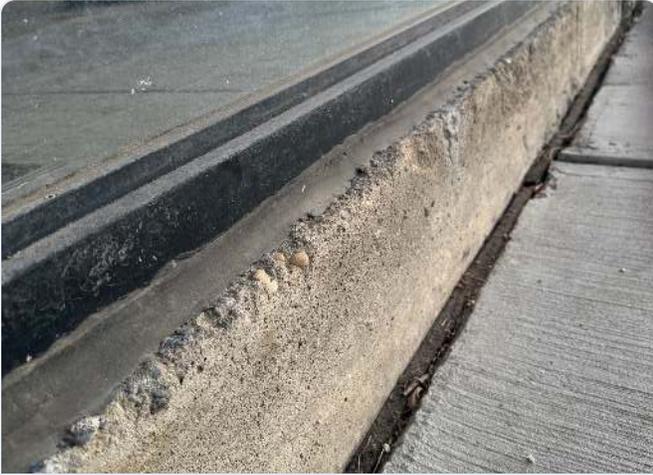
A1020.07 Grade Beams (Concrete)

System / Assembly	Location	Condition	Concern	Priority	Install Yr	Design Life
Grade Beams (Concrete)	Exterior, at base of window system	● C	Spalling and deterioration of the concrete grade beam, which can lead to further structural degradation and potential water intrusion if not addressed. The exposed aggregate indicates loss of the cementitious paste.	Short-Term	2010	75 yr
ACTION: Repair spalled concrete sections of the grade beam. This may involve chipping away loose material, cleaning the surface, applying a bonding agent, and patching with a suitable concrete repair mortar. Monitor for further deterioration.						
Grade Beams*	General	● A		N/A	2010	100 yr
ACTION: Lifecycle replacement.

CONDITION: ● C (Acceptable)

RECOMMENDATION: Repair spalled concrete sections of the grade beam. This may involve chipping away loose material, cleaning the surface, applying a bonding agent, and patching with a suitable concrete repair mortar. Monitor for further deterioration.

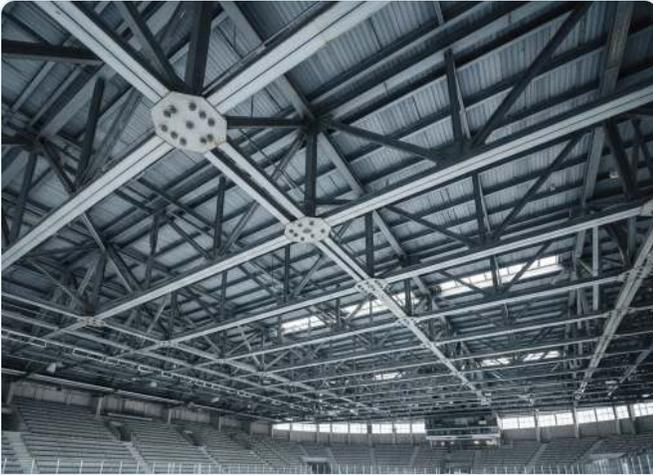
B1020.01.03.02 Roof Steel Trusses*

CONDITION: ● A (Excellent)
LOCATION: Arena Roof Structure
COMPONENT: Roof Structural Frame
DEFICIENCY: None noted
RECOMMENDATION: Routine maintenance.

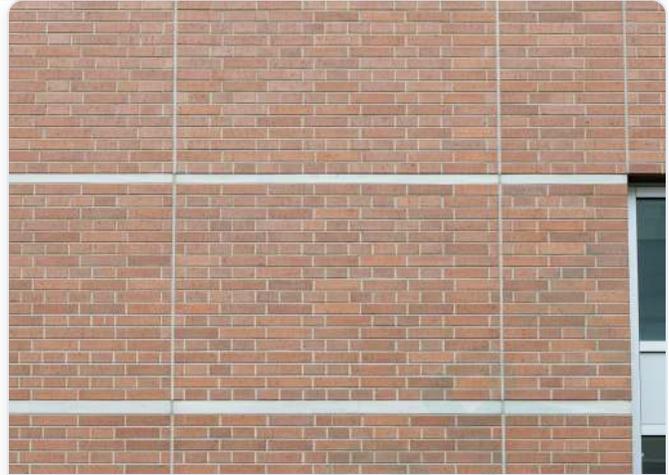
B2010.01.02.01 Masonry Cladding*

The exterior wall system of the Westbrook Community Arena is primarily comprised of two distinct cladding materials: masonry and phenolic panel siding. The masonry cladding, installed in 2010 with an expected design life of 75 years, is generally observed to be in good condition. However, a specific deficiency was noted where five individual masonry panels exhibit cracking or are entirely missing. This localized damage compromises the aesthetic integrity and could potentially lead to moisture infiltration if not addressed. The phenolic panel siding, also installed in 2010 with an anticipated design life of 50 years, is in excellent condition with no notable concerns or deficiencies observed during the assessment.

CONDITION: ● B (Good)
LOCATION: Exterior - Multiple Elevations
COMPONENT: Exterior Wall Exterior Skin
DEFICIENCY: Five panels are cracked or missing.
RECOMMENDATION: Replace damaged cladding panels.

The identified damage to the masonry cladding constitutes a short-term priority. The replacement of the five cracked or missing panels is recommended to prevent further deterioration, maintain the building's envelope integrity, and restore its appearance. This repair is considered a deferred maintenance item requiring prompt attention. Conversely, the phenolic panel siding is performing as expected and does not require any immediate intervention. Its end-of-life replacement should be factored into long-term capital reserve planning, aligning with its projected design life.

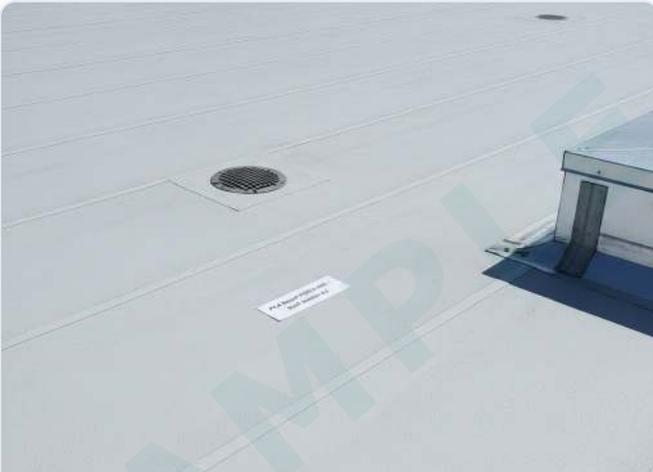
B3010.04.05 Single-Ply Membrane Roof**

CONDITION: ● B (Good)
LOCATION: Roof Level
COMPONENT: B3010.04.05 Membrane Roofing (Single Ply EPDM)
DEFICIENCY: Localized areas of loose membrane observed; minor patched punctures from mechanical damage. No active leaks reported. Manufacturer warranty covers leak repairs in early years.
RECOMMENDATION: Full membrane replacement. Noted deficiencies may shorten service life.

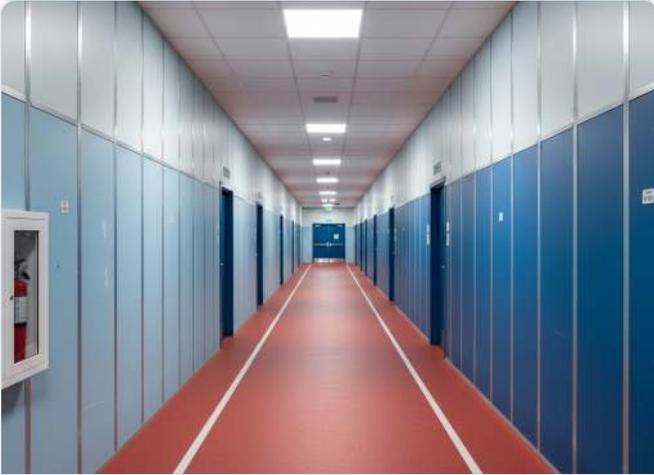
C1010.01.07 Metal Stud Partitions*

CONDITION: ● A (Excellent)
LOCATION: Multi-Purpose Room
COMPONENT: C1010.08 Other Partitions - 2010
DEFICIENCY: Minor surface damage in the multi-purpose room.
RECOMMENDATION: Patch and repaint as routine maintenance.

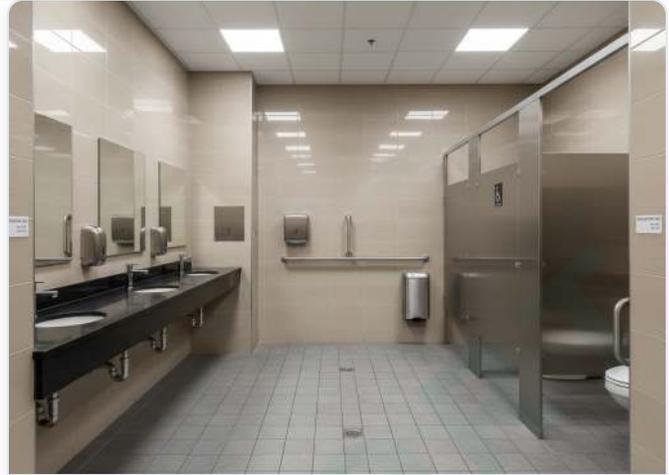
C3010.06.01 Wall Ceramic Tile**

CONDITION: ● A (Excellent)
LOCATION: Change Rooms
COMPONENT: C3010.02 Wall Paneling - 2010
DEFICIENCY: None noted
RECOMMENDATION: Lifecycle replacement

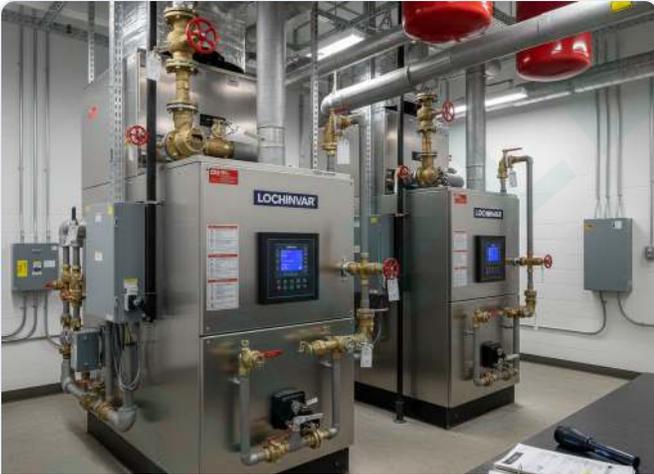
D3020.02.01 Heating Plant**

CONDITION: ● N/A
LOCATION: Main Mechanical Room
COMPONENT: Heat Generating Systems
DEFICIENCY: None noted
RECOMMENDATION: Lifecycle replacement.

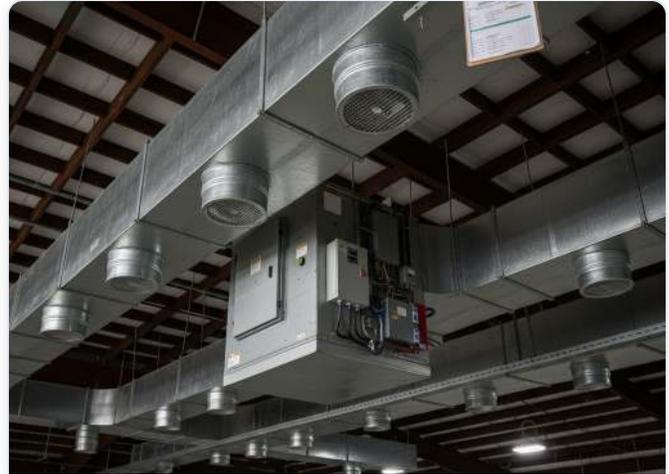
D3040.01.01 Air Handling Unit (Overhaul)**

CONDITION: ● A (Excellent)
LOCATION: Main Mechanical Room
COMPONENT: HVAC Distribution
DEFICIENCY: None noted
RECOMMENDATION: Mid-life overhaul including VFD replacement.

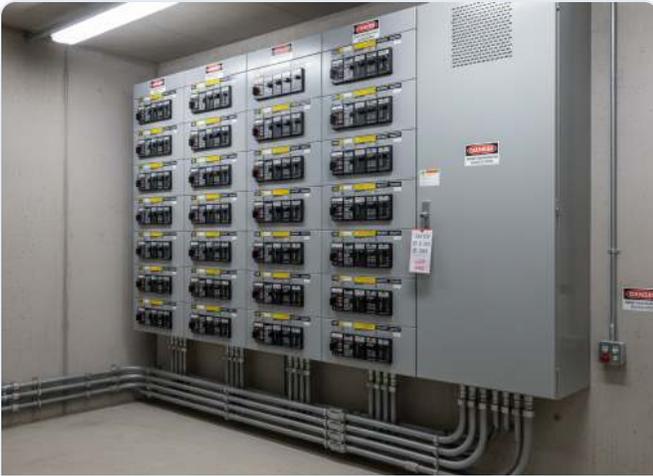
D5010.03 Main Disconnect Switches**

CONDITION: ● A (Excellent)
LOCATION: Main Electrical Room
COMPONENT: Electrical Service and Distribution
DEFICIENCY: None noted
RECOMMENDATION: Lifecycle replacement.

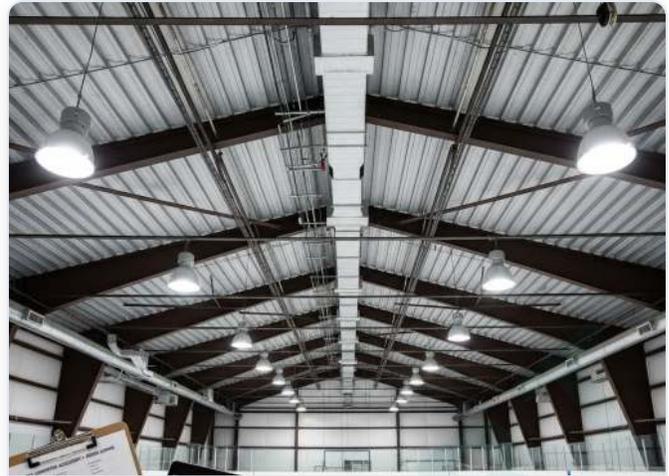
D5020.01 Branch Wiring*

CONDITION: ● A (Excellent)
LOCATION: Main Electrical Room
COMPONENT: D5020.01 Electrical Branch Wiring
DEFICIENCY: None noted
RECOMMENDATION: Routine maintenance.

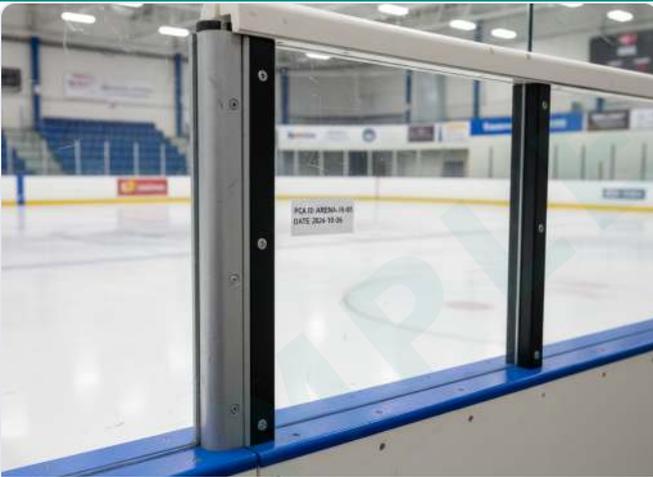
F1040.02 Dasher Boards**

CONDITION: ● C (Acceptable)
LOCATION: Ice Rink
COMPONENT: Special Facilities
DEFICIENCY: Glazing and panels scuffed from puck impacts; cap damaged in spots.
RECOMMENDATION: Lifecycle replacement.

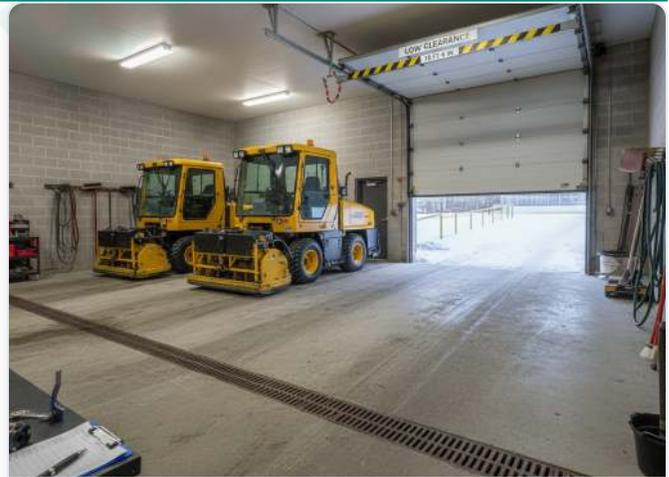
F1040.02 Resurfacer Water Heaters**

CONDITION: ● A (Excellent)
LOCATION: Ice Resurfacer Room
COMPONENT: Special Facilities
DEFICIENCY: None noted
RECOMMENDATION: Lifecycle replacement.

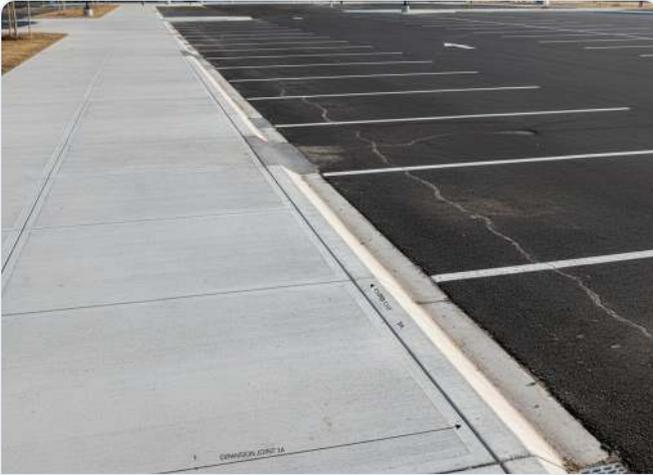
G2030.04 Concrete Sidewalks**

CONDITION: ● A (Excellent)
LOCATION: Exterior - Perimeter
COMPONENT: Pedestrian Paving
DEFICIENCY: None noted
RECOMMENDATION: Lifecycle replacement.

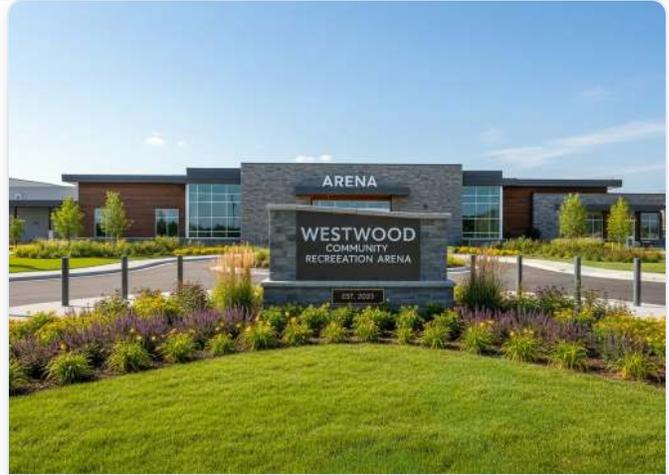
G2050.05 Landscaping*

CONDITION: ● A (Excellent)
LOCATION: Exterior - Grounds
COMPONENT: Landscaping
DEFICIENCY: None noted
RECOMMENDATION: Continue monitoring.

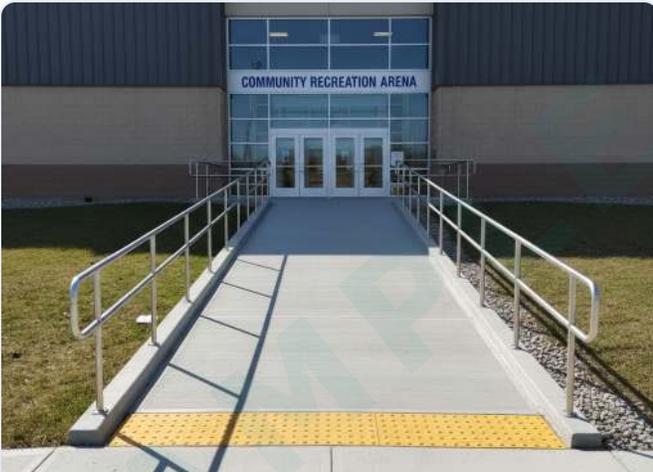
K4010.01 Barrier-Free Route*

CONDITION: ● N/A
LOCATION: General
COMPONENT: Barrier-Free Access
DEFICIENCY: None noted
RECOMMENDATION: Continue monitoring.
